Understanding Substantial Structural Damage in the International Existing Building Code

EXAMPLE — EARTHQUAKE DAMAGE

EXAMPLE 2– HURRICANE DAMAGE

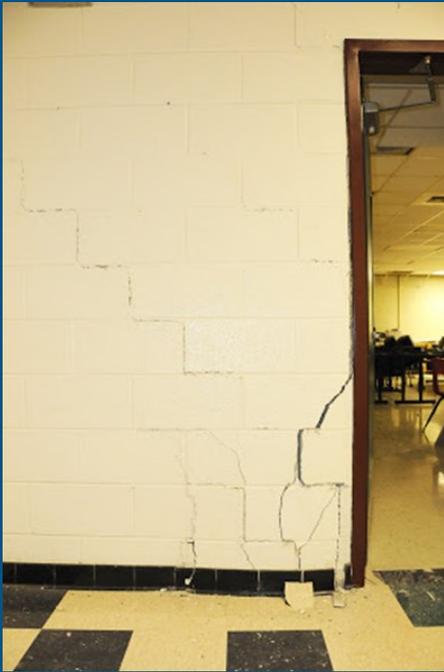
Figure 1. Stepped cracking in masonry wall with buckling and out-of-plane spalling of CMU shell at toe of wall segment.

- CMU partitions: Stepped cracking within mortar joints (Figures 1 and 2), typical in both stories, both directions. Vertical cracks adjacent to encased steel columns. Horizontal separation between CMU units in multiple locations, up to one-inch wide in four places in the north-south direction in the second story (Figure 2). Crushed, spalled or buckled masonry units (Figure 1) in four locations in the first story, at the toe of north-south wall segments.

The two other damage patterns – one-inch wide cracks and buckled or spalled units – do indicate a more fundamental change to the north-south walls' pre-earthquake condition. With the joints separated and the toe of certain wall segments starting to disintegrate, it can be reasonably judged that the damaged wall would perform in a degraded fashion under additional earthquake loading. Does this represent a 33 percent capacity loss to an entire story as the definition of SSD requires? This is a matter of judgment, and any conclusion is subject to review. For this example, it is judged that the change of state represented by the two advanced damage patterns does represent a substantial capacity loss, so **it is concluded that SSD to the lateral system has occurred** at each story in the north-south direction.

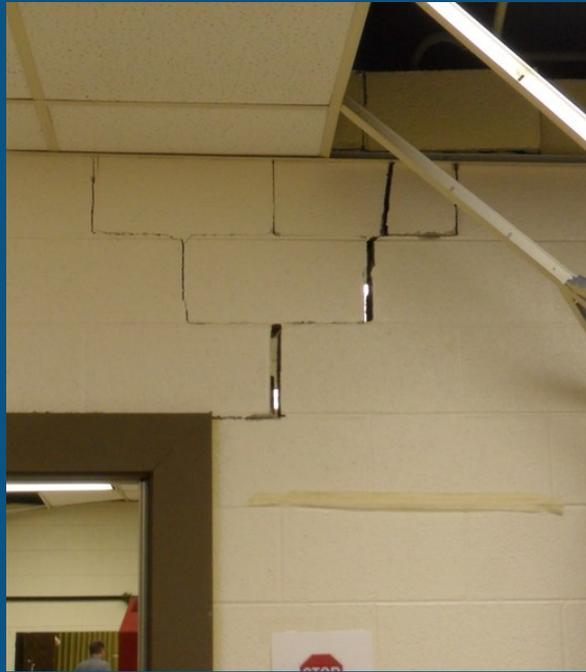
Figure 2. Stepped cracking in masonry wall with up to 1 inch horizontal separation between units.

Narrow stepped cracks along CMU joints are typically the first signs that a wall has felt some in-plane loading. Normally, however, this light cracking does not indicate a substantial capacity loss. That is, if such a wall were to be loaded again by another earthquake, its ultimate strength and stability would be similar whether or not it started with light joint cracks. Thus, the stepped cracking observed throughout the building does not represent SSD.

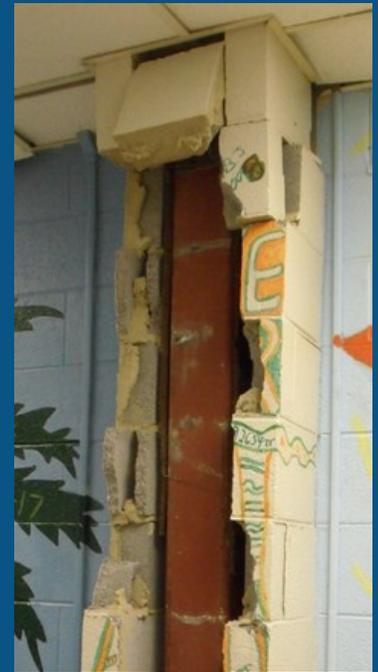
Figure 3. Damaged CMU removed, revealing undamaged steel tube column.

- Steel floor/roof framing and tube columns: No apparent damage. The frame clearly swayed, but with damaged CMU removed in a few locations (Figure 3), no member buckling, weld damage, or bolt damage was observed, and none is suspected.

SSD to the gravity system: With no apparent damage to the steel framing, and with the steel gravity system apparently unaffected in its ability to carry the existing dead and live loads, **it is concluded that SSD to the gravity system has not occurred.**

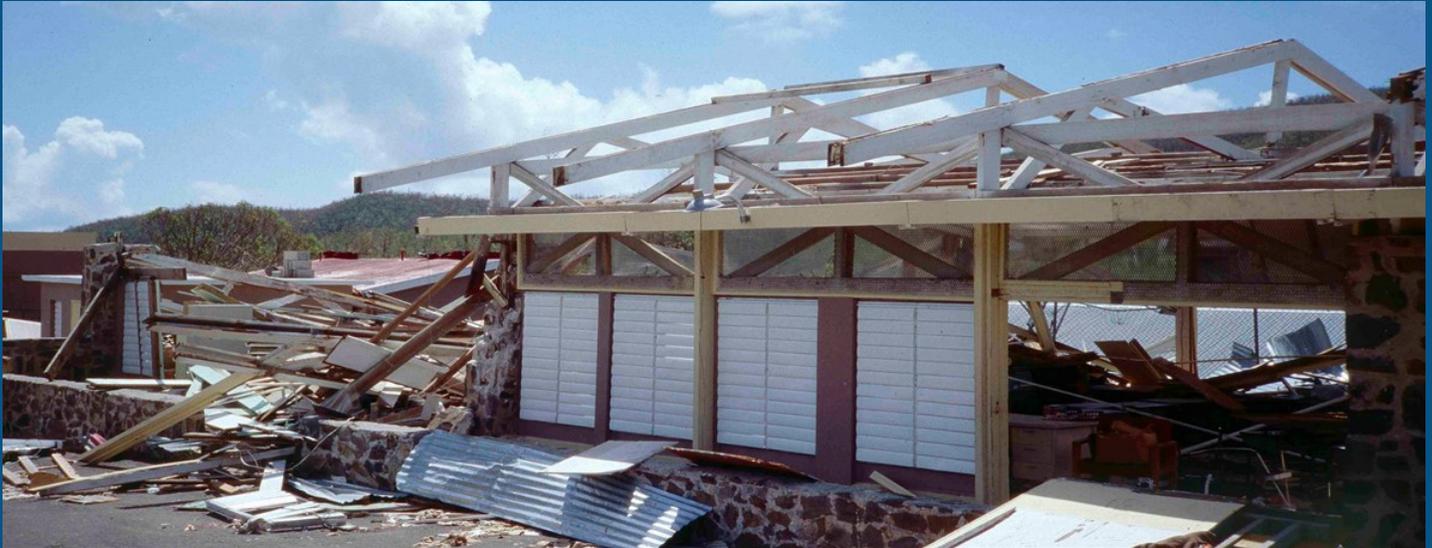
Figure 4. Two classrooms at the far end of the six-classroom building completely destroyed. Photo:FEMA

- Roof trusses: Trusses lifted and blown off over two classrooms at one end, about one third of the building footprint (Figure 4).
- Post and beam framing: Framing collapsed where the trusses blew off (Figure 4).
- Shear walls: Two short-direction shear walls collapsed at the end where the trusses blew off (Figure 4). Other short-direction walls and all long-direction walls were undamaged by wind, but there was damage due to rain through the damaged roof.
- Roof: Roof panels blown off over about four classrooms, or two thirds of the building footprint.
- Nonstructural components: Windows and shades damaged by wind-borne debris. Extensive water damage to interior finishes.
- Contents: Extensive loss due to wind and water damage.

SSD to the gravity system: About one third of the building was completely destroyed once the trusses blew off. This exceeds the 30 percent area criterion and the 20 percent capacity loss criterion in the SSD definition. Therefore, **it is concluded that SSD to the gravity system has occurred.**
